# Dangerous Downtown Streets

## Safety Problems and Solutions for Eureka's 4th & 5th Street Corridor (US-101)

October 2025

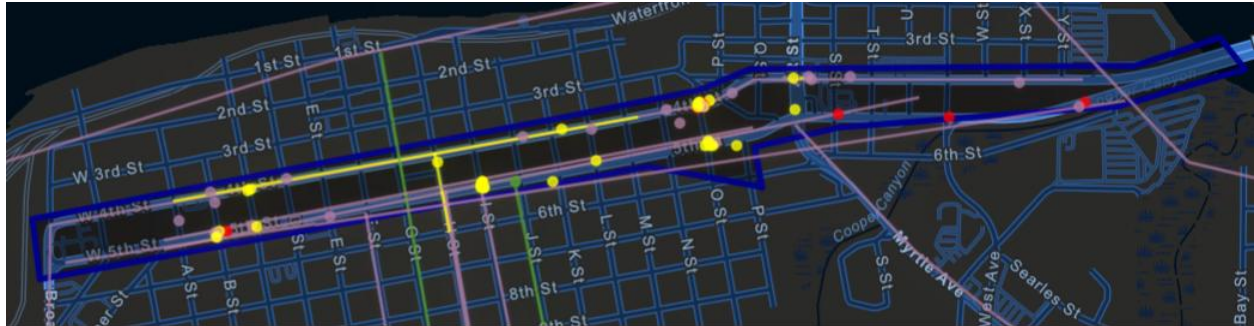
*Street Story reports in the 4th & 5th Street corridor. Image: UC Berkeley SafeTREC*

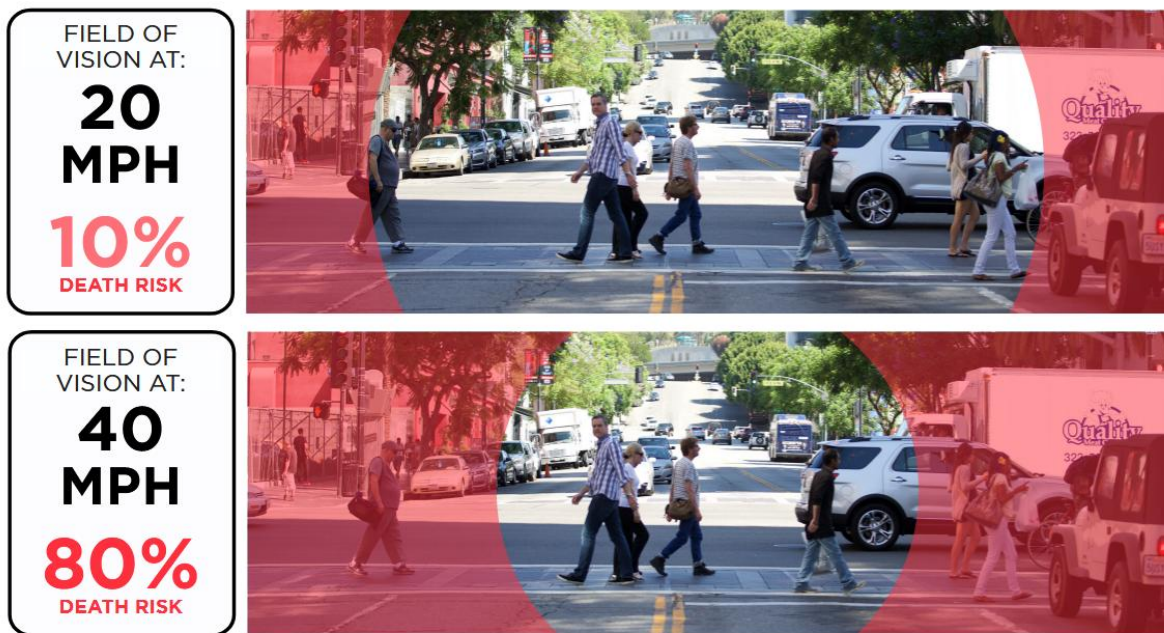
The effect of vehicle speed on a driver's field of vision and the chance of pedestrian death in a crash. Image: LADOT.

High traffic speeds are the focus of many reported pedestrian safety concerns in the corridor. It is well established that high vehicle speeds both increase the likelihood of a crash and increase the severity of the outcome, especially for pedestrians and bicyclists. Additionally, high speeds are known to be a major contributor to other types of problems reported in the corridor, ranging from the failure of drivers to yield (right-of-way violations) to high noise levels. Drivers traveling at higher speeds also have a narrower field of view, limiting their ability to see pedestrians, bicyclists, and motorists attempting to cross the street. Therefore, the most significant intervention we recommend is the conversion of a current car and truck lane to a protected bikeway. Both removal of general traffic lanes and addition of protected bikeways are proven traffic calming strategys. Reducing traffic speeds saves lives by reducing the likelihood of crashes and reducing the severity of crashes which do occur.

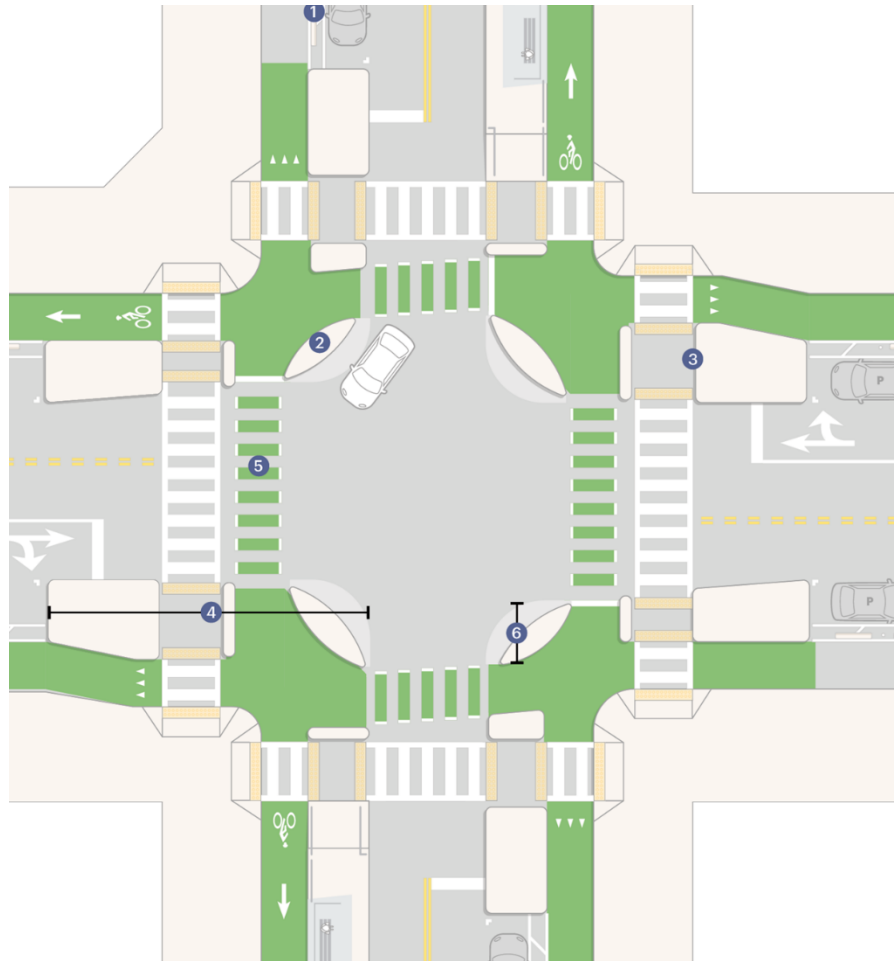
Example of a protected intersection. Image: NACTO.

protected intersection. A protected intersection provides corner islands behind which bicyclists can queue in a high-visibility but protected location before crossing, and encourages safe, two-stage left turns. We recommend protected intersection design at most intersections in the corridor, and bike turn boxes in other locations. Where parking lanes reduce pedestrian visibility, protected intersections should be designed with pedestrian queuing areas adjacent to bicycle queuing and corner islands to increase pedestrian visibility.
